Water-Supply Paper 773—E

THE NEW YORK STATE FLOOD OF JULY 1935

BY
HOLLISTER JOHNSON

Contributions to the hydrology of the United States, 1936
(Pages 233-268)

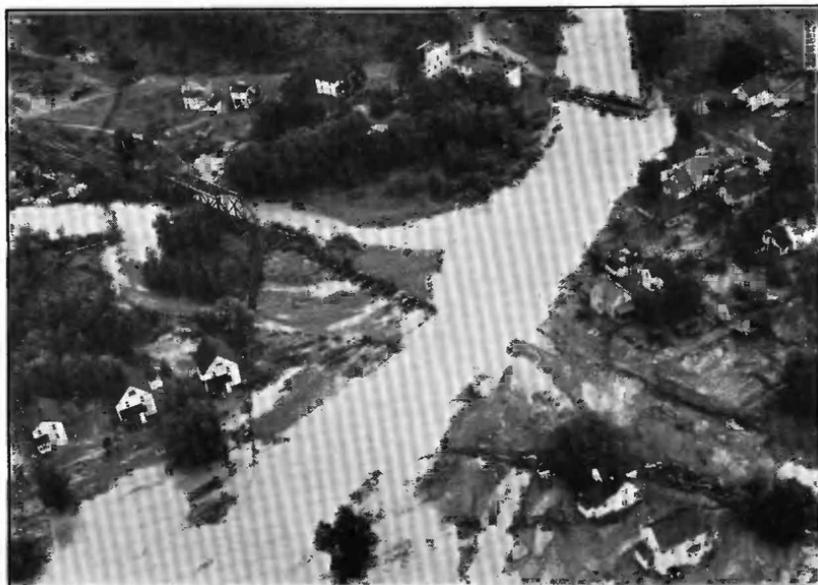
A. SALMON CREEK AT MYERS, N. Y., SHOWING FORCE OF THE FLOOD WATERS.

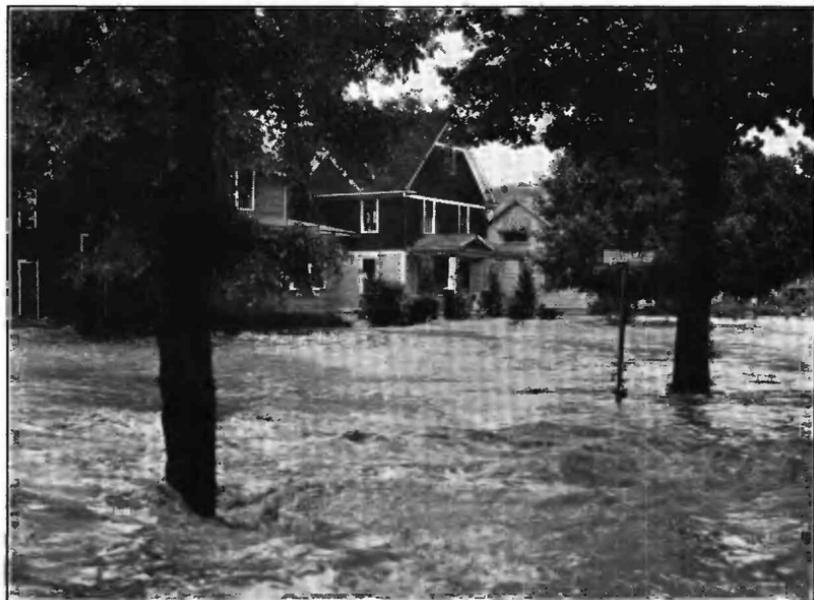
B. INUNDATION FROM CHENANGO RIVER, BINGHAMTON, N. Y.

On the larger streams the flatter slopes and broader valleys caused the flood waters to assume less destructive velocities and to overflow the banks, thus causing less spectacular but very real loss by inundation as shown in plate 23,B.

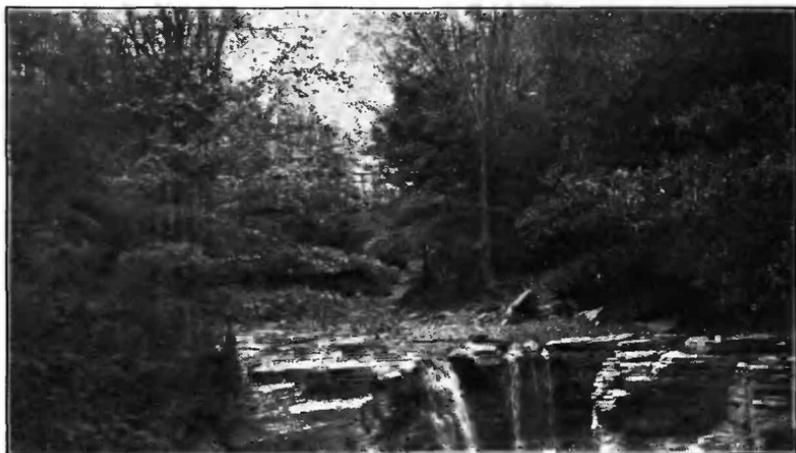
SLOPE-AREA REACH ON GLEN CREEK NEAR TOWNSEND, N. Y.

Looking upstream. Section B was taken about 50 feet above the falls, and section A was taken upstream, above the highway bridge. The bed of the creek at section A was composed chiefly of coarse gravel with a short section of ledge rock. At section B the bed of the creek was flat, smooth shale. The right bank of the creek was shale of fairly regular section. The left bank was coarse stone and dirt and fairly uniform. Both banks contained brush and trees, which were generally above the high-water line. The falls shown in the picture were 8 to 10 feet high and were not submerged from below during the flood. The channel through the section has a slight curvature to the left.

The maximum intensity of discharge (presumably a momentary peak) as determined by measurements in the field, shown on figure 22 and plate 24, was 2,520 second-feet per square mile, from 2.91 square miles of the Glen Creek drainage basin near Townsend, N. Y., corresponding to a run-off rate of 3.90 inches per hour over the drainage basin. The run-off from 2.34 square miles of the Softwater Creek drainage basin near Cold Springs, N. Y., was 2,030 second-feet per square mile, or at the rate of 3.15 inches per hour over the drainage basin. From the indications of washout damage and other evidence it seems probable that there were numerous small streams whose intensities of discharge were equal to those thus determined, if not greater. Unfortunately, suitable locations for determinations of discharge were not found on these small streams. Other determinations of noteworthy intensities are given in the table.

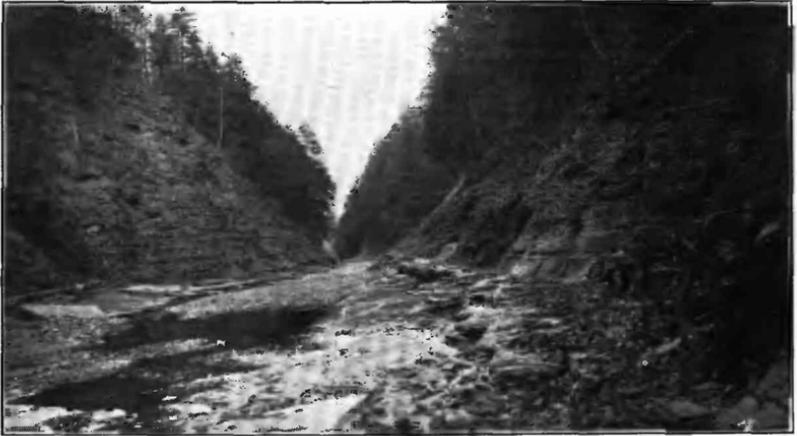
SLOPE-AREA REACH ON GLEN CREEK NEAR WATKINS GLEN, N. Y.

Looking downstream. Section A was taken in the foreground of the picture. Section B was taken at the bend where the man is standing. Section C was taken near the end of the bare rock showing on the right bank. The bed of the creek was *smooth, flat shale covered in spots by medium-sized gravel*. Both banks were rock, steep, and, although rough, relatively uniform. There were no trees below the high-water line. About 75 feet below section C there was a falls 10 to 12 feet high. There was no indication of submergence of the falls from below during the flood.

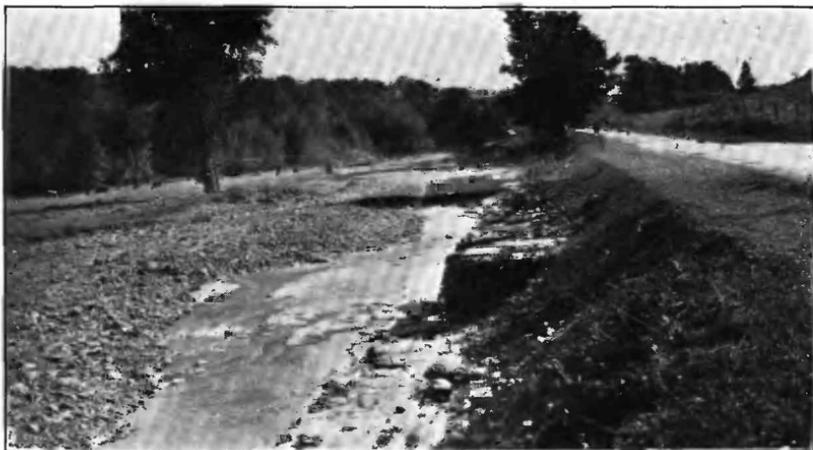
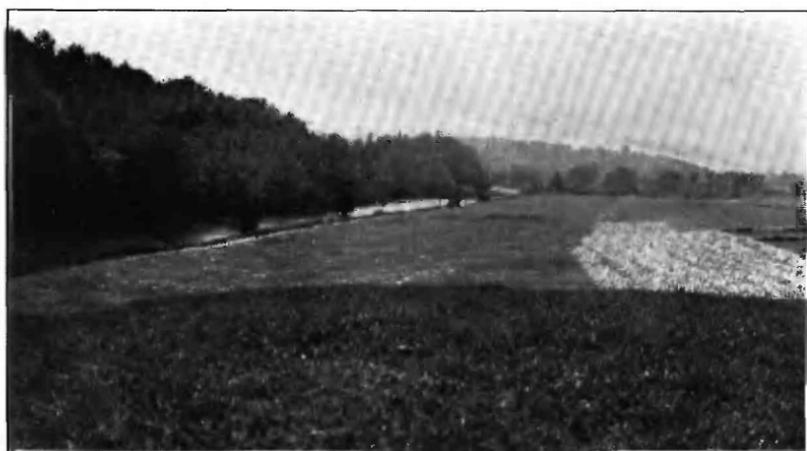
TYPICAL CHANNELS WITH "n" ASSUMED FOR EACH.

In A "n" assumed 0.30; reach extended from large elm on left bank to barn on right bank.
In B "n" assumed 0.030 for main channel and overflow on right bank, 0.100 for wooded section on left bank.

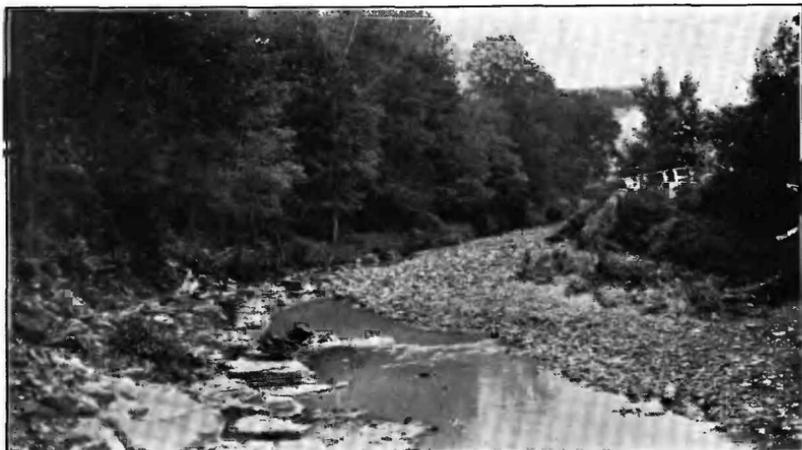
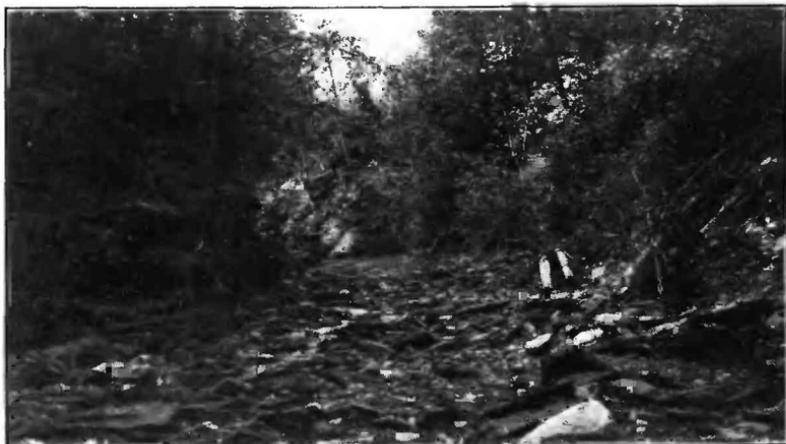
TYPICAL CHANNELS WITH "n" ASSUMED FOR EACH.

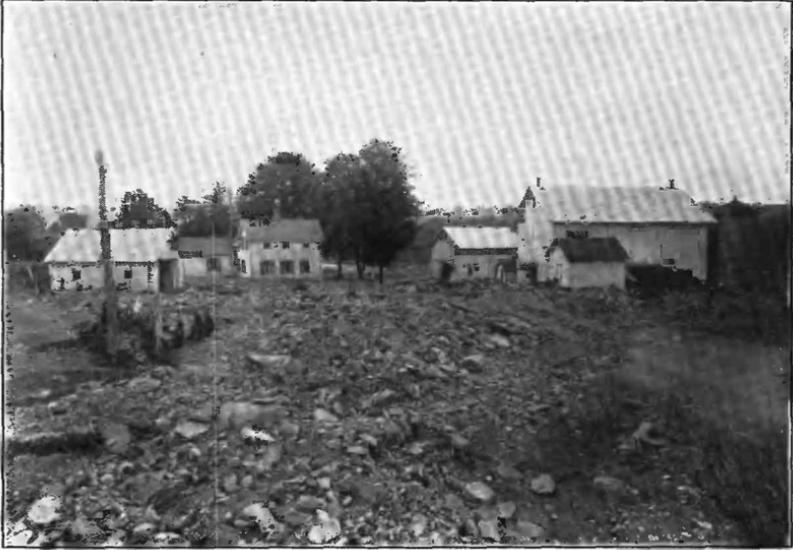
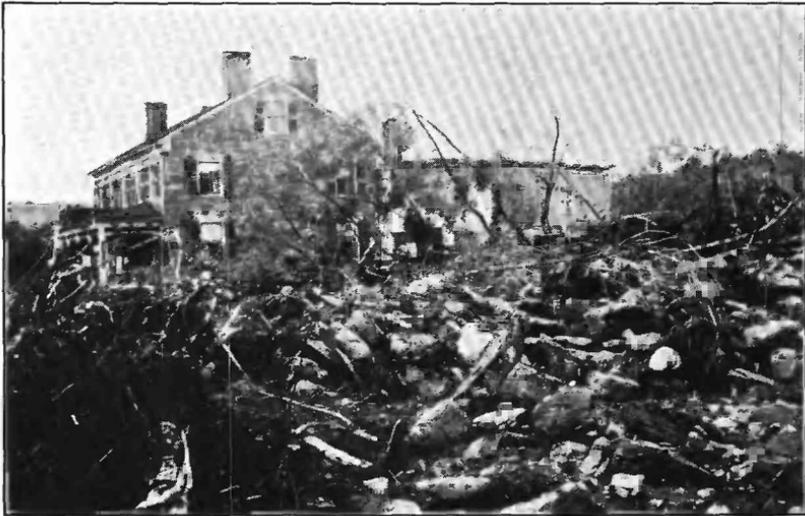
A. CHARLES BECKWITH FARM, SOUTH OF OXFORD, N. Y., SHOWING TYPICAL DAMAGE BY STONES AND GRAVEL TRANSPORTED BY SMALL STREAMS.

B. STONE HOUSE FARM, NEAR NORWICH, N. Y., SHOWING TYPICAL DEBRIS CARRIED BY SMALL STREAMS.

Farm lands suffered generally from gullying, from being buried under stones and gravel, and from inundation. On plate 30 is shown the character of the damage wrought by the small streams that washed tons of stones and gravel onto the farm lands.

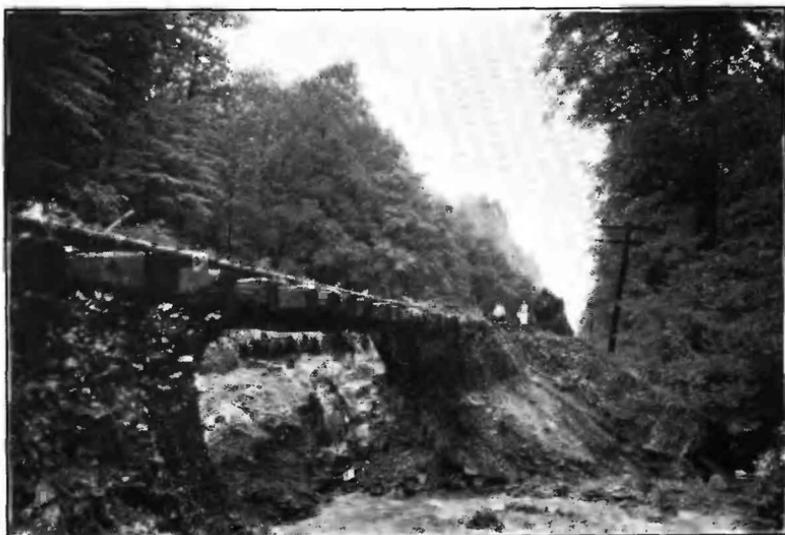
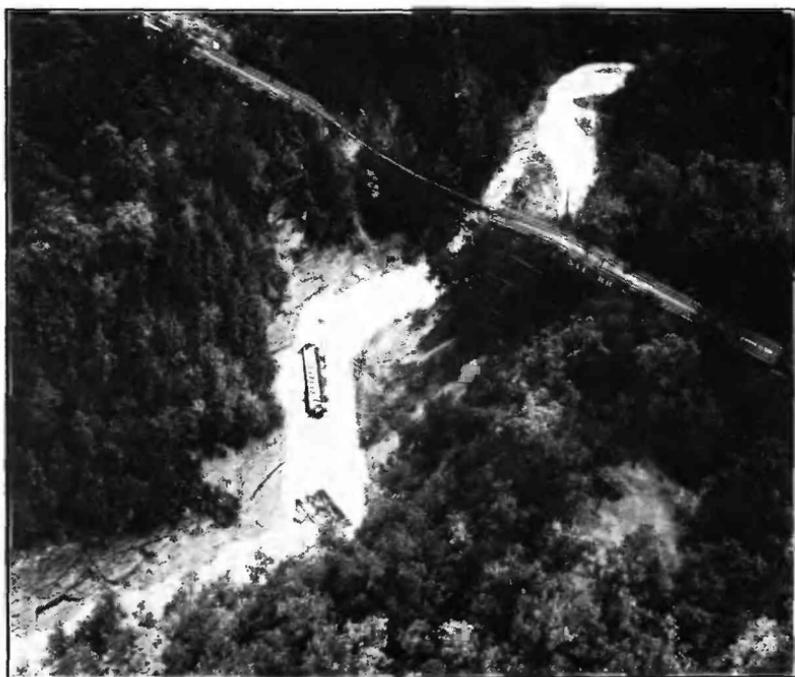
A. WASHOUT OF ROADBED, LEHIGH VALLEY RAILROAD.
The wreck of a passenger train was narrowly averted at this point.

B. NEW YORK CENTRAL RAILROAD AT WATKINS GLEN, N. Y., SHOWING HIGH BRIDGE OVER GLEN CREEK DESTROYED DURING THE FLOOD.
Courtesy of International News Photos, Inc.

Railroad operations were suspended by the destruction of roadbeds and bridges and inundation of property and equipment. Plates 31 and 32 show the type of damage to the railroads.

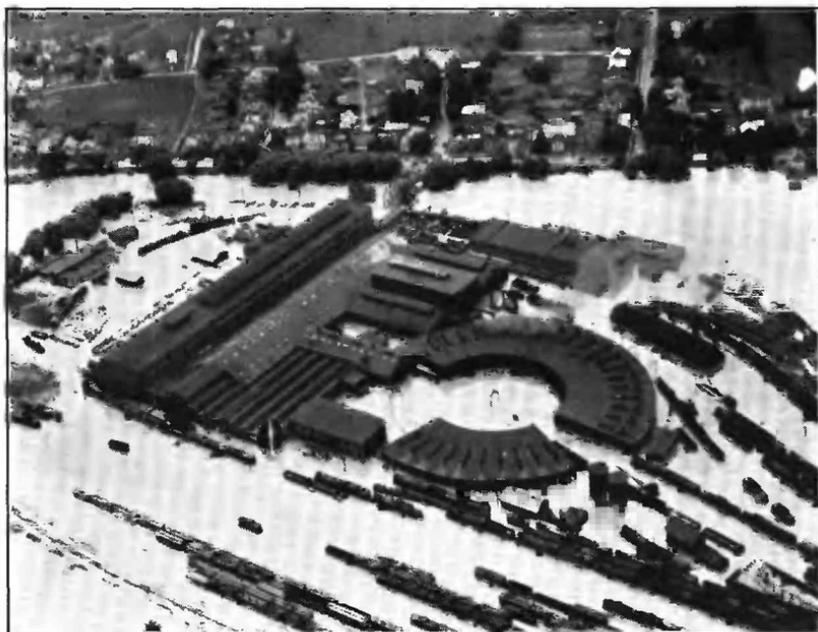
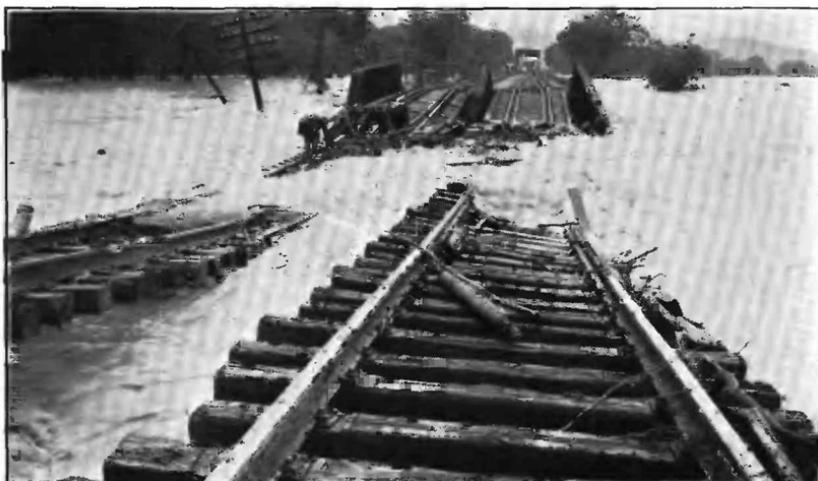
A. ERIE RAILROAD AT HORNELL, N. Y., SHOWING ROUNDHOUSE AND EQUIPMENT BURIED UNDER FLOOD WATERS

B. LACKAWANNA RAILROAD NEAR BATH, N. Y., SHOWING TYPICAL FLOOD CONDITIONS

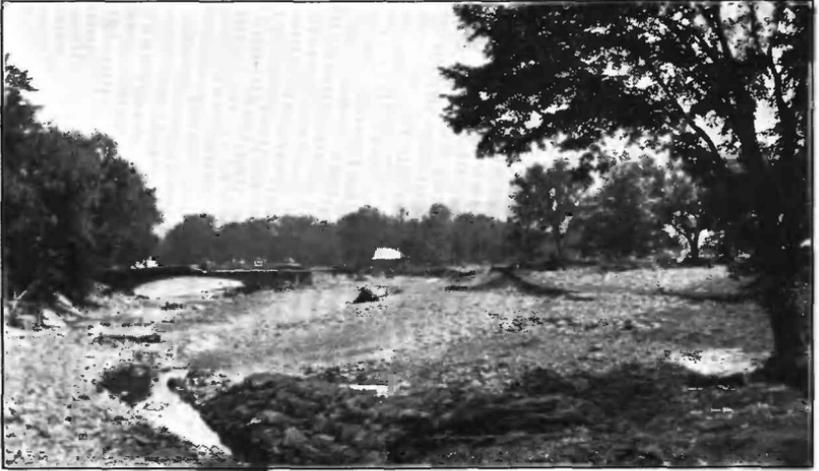
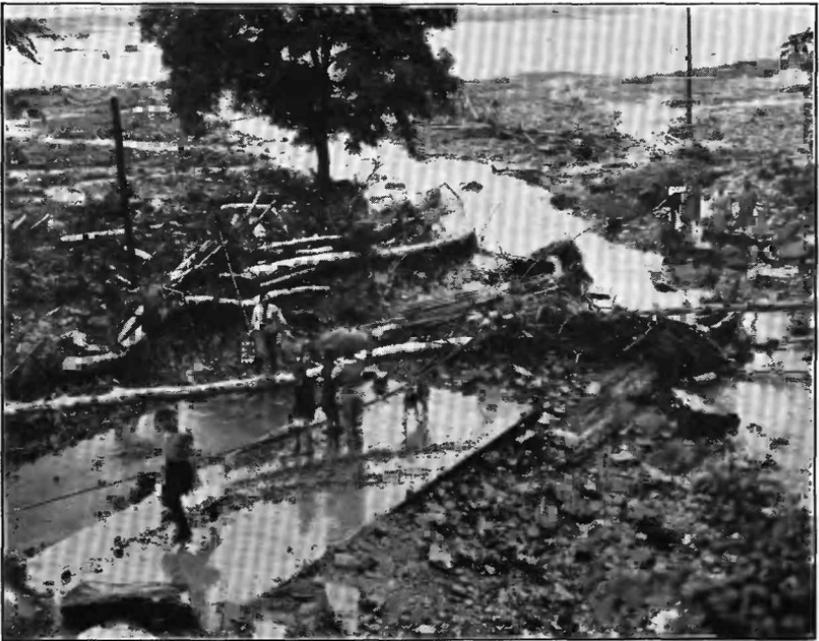
A. TAUGHANNOCK FALLS STATE PARK, N. Y., SHOWING DESTRUCTION OF ROAD DUE TO INADEQUACY OF BRIDGE TO CARRY FLOOD WATERS.

B. DESTRUCTION WROUGHT BY FLOOD ALONG TAUGHANNOCK BOULEVARD, ITHACA, N. Y.

Miles of highways were rendered impassable by the destruction of the pavements, bridges, and culverts and by the inadequacy of the structures to pass the flood waters. Plates 33 to 35 show some of the various types of damages to the highways.

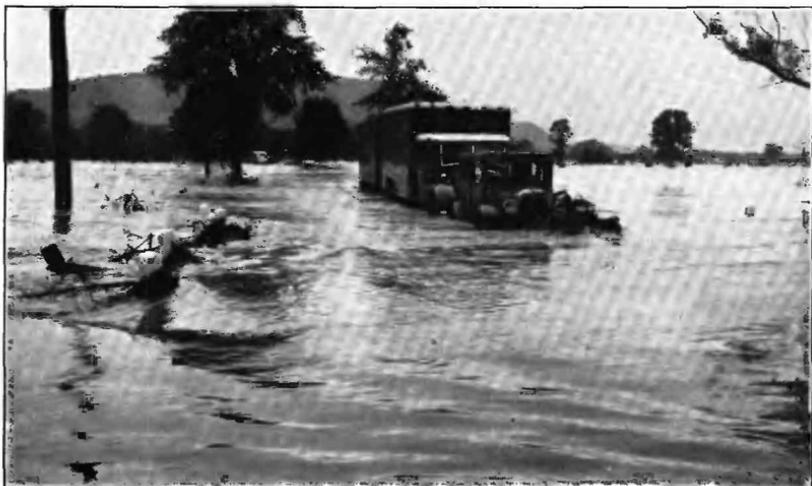
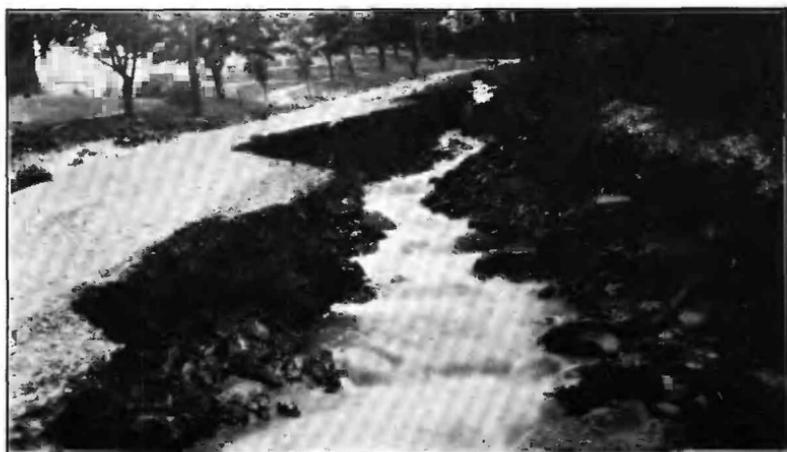
A. CARS AND TRUCKS MAROONED AND ABANDONED ON FLOODED HIGHWAY, KANONA, N. Y.

B. ROAD DESTROYED BY GULLYING, NORWICH, N. Y.

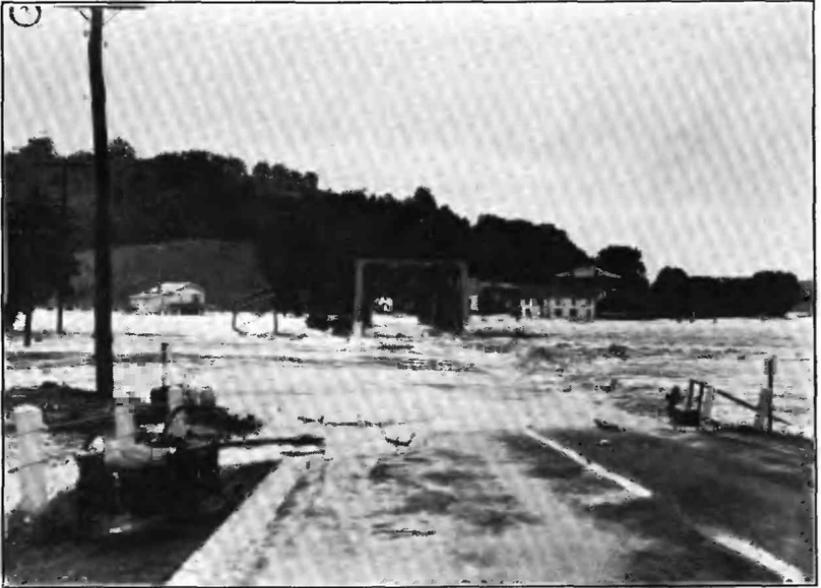
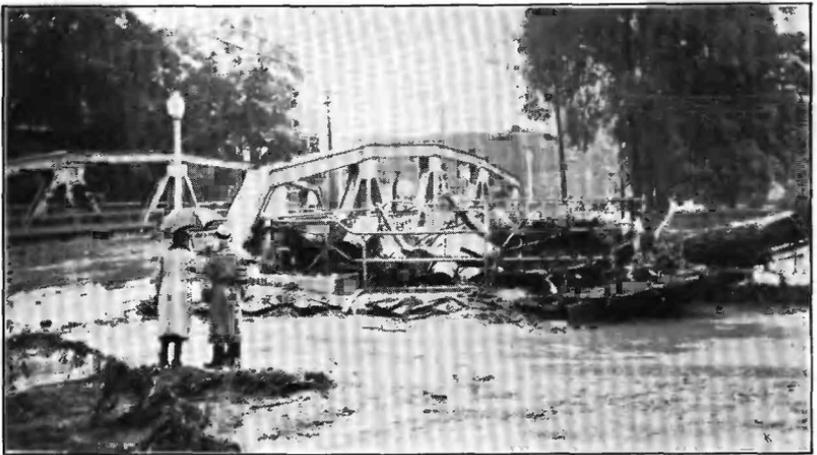
A. CHENANGO FORKS, N. Y., AT JUNCTION OF TIOUGHNIOGA AND CHENANGO RIVERS, SHOWING INADEQUACY OF BRIDGE OVER TIOUGHNIOGA RIVER TO CARRY FLOOD WATERS.

B. INADEQUACY OF SENECA STREET BRIDGE OVER CANACADEA CREEK, HORNELL, N. Y., TO CARRY FLOOD DEBRIS.

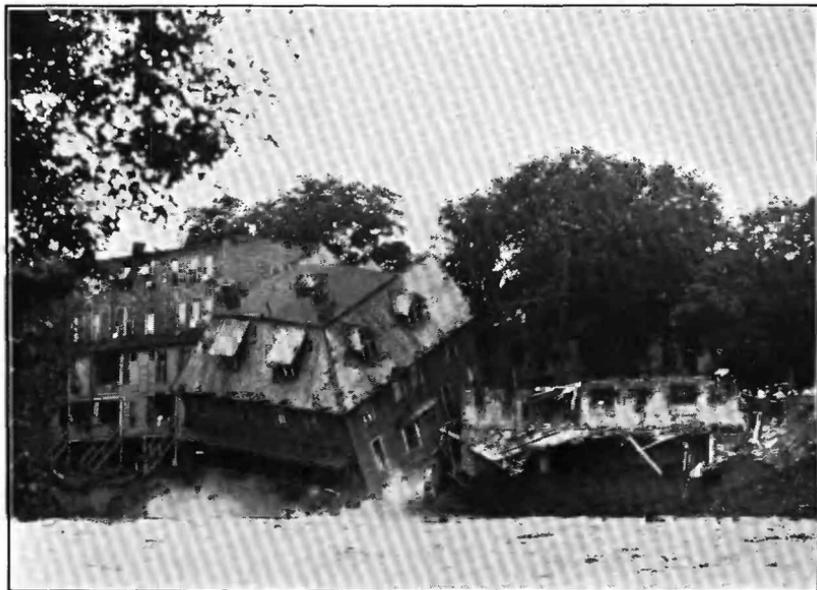
A. O'DAY HOUSE ON FRONT STREET, BINGHAMTON, N. Y., TOPPLING INTO THE FLOOD WATERS OF CHENANGO RIVER.

Buildings, automobiles, and private property of many kinds were destroyed, wrecked, buried, and inundated to the great loss of the owners. Plates 36 and 37 show some of the damages to private property.

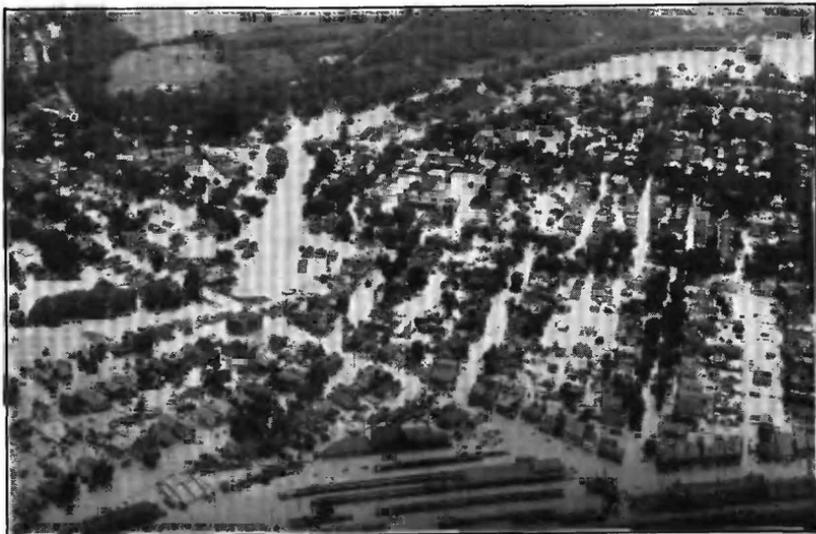
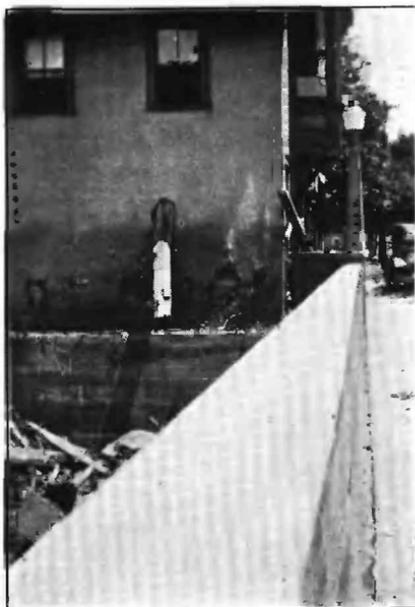
A. INUNDATION OF HOMES AND BUILDINGS, HORNELL, N. Y.
Courtesy of the Gannett Newspapers.

B. TELEPHONE POLE DRIVEN THROUGH SIDE WALL AND CEILING INTO THE SECOND FLOOR OF A HOME ON RIVER STREET, HORNELL, N. Y.
